Chicken Skin Wastewater

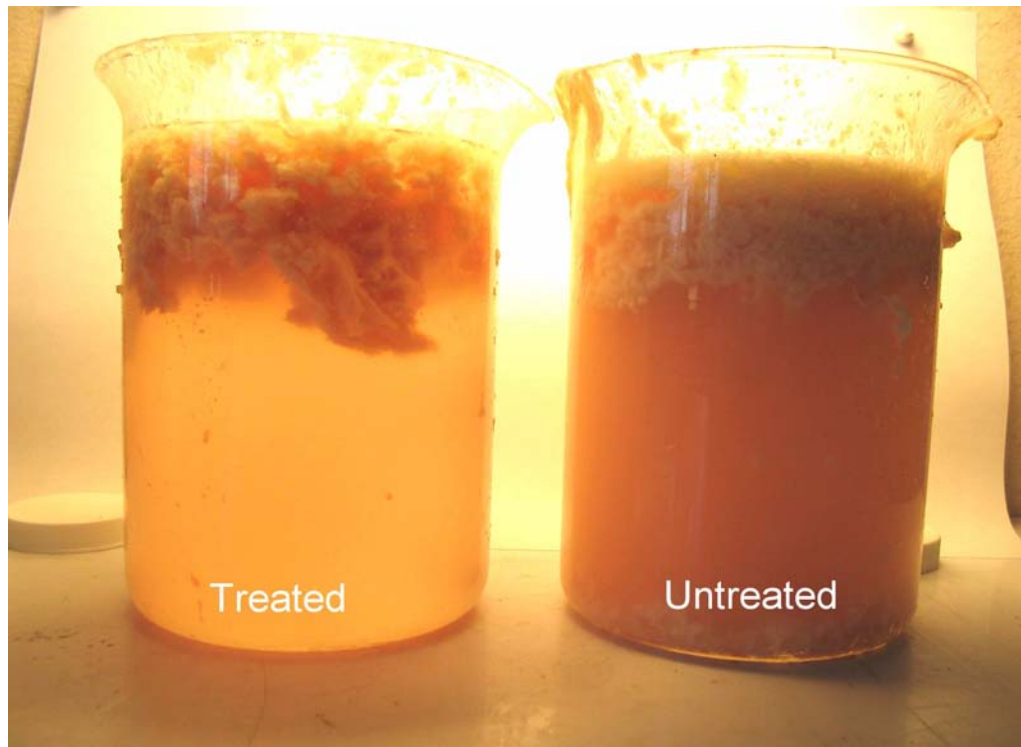
The wastewater from a poultry processing plant contained almost exclusively skins, and high concentrations of fat for approximately 8 hours of the production day. This wastewater created heavy blinding problems on their dewatering system. In lab tests the untreated wastewater would completely blind 30 thousandths wedge wire screen and inhibit dewatering. IE-614 treated the wastewater with no pH adjustment at a very low dosage of 0.08 grams per 1000 ml. This is equivalent to 6.6 lbs/10,000 gallons of wastewater. The treated wastewater would dewater through a 30 thousandths wedge wire screen in less than 30 seconds. There was no blinding on the screen.
